DEPARTMENT OF TRANSPORTATION

Office of Structural Materials

Contract #: 04-0120F4Cty: SF/ALA Rte: 80 PM: 13.2/13.9File #: 1.28**WELDING INSPECTION REPORT****Resident Engineer:** Casey, William**Address:** 333 Burma Road**City:** Oakland, CA 94607**Report No:** WIR-028405**Date Inspected:** 15-Sep-2012**Project Name:** SAS Superstructure**OSM Arrival Time:** 700**Prime Contractor:** American Bridge/Fluor Enterprises, a JV**OSM Departure Time:** 1530**Contractor:** American Bridge/Fluor Enterprises, a JV**Location:** Job Site**CWI Name:** Cris Concha and Scott Kurtom**CWI Present:** Yes No**Inspected CWI report:** Yes No N/A**Rod Oven in Use:** Yes No N/A**Electrode to specification:** Yes No N/A**Weld Procedures Followed:** Yes No N/A**Qualified Welders:** Yes No N/A**Verified Joint Fit-up:** Yes No N/A**Approved Drawings:** Yes No N/A**Approved WPS:** Yes No N/A**Delayed / Cancelled:** Yes No N/A**Bridge No:** 34-0006**Component:** SAS OBG**Summary of Items Observed:**

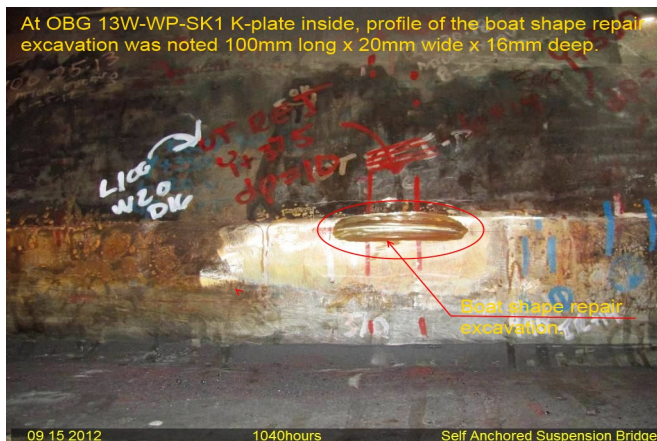
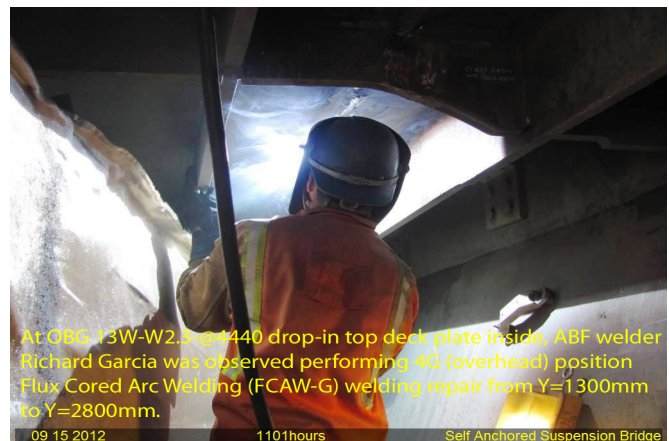
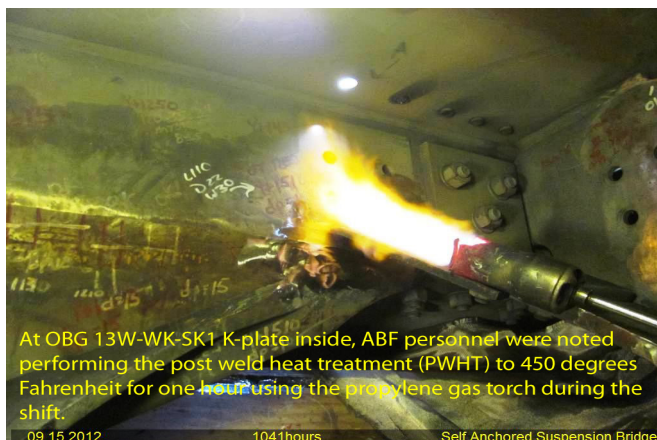
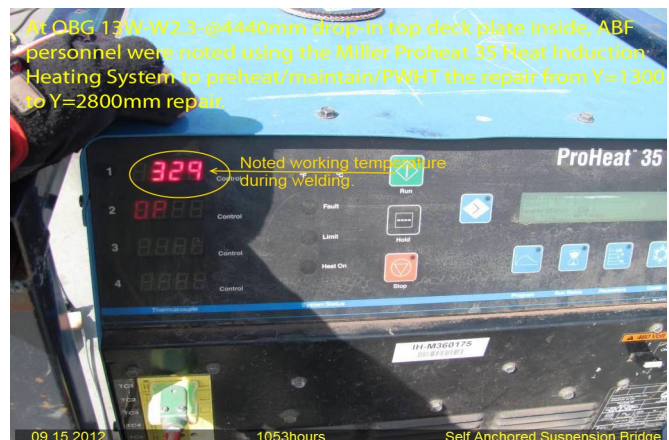
The welder was noted using propylene gas torch to preheat the repair area and its vicinity to 325°F and as soon as the required temperature was attained the welder started performing the welding repair. Welder James Zhen was observed manually welding in 2G (horizontal) position utilizing Shielded Metal Arc Welding (SMAW) with 3.2mm diameter E7018H4R electrode implementing Caltrans approved welding procedure ABF-WPS-D15-1004 Repair. Welder James Zhen was noted welding repair at Y=370mm having boat shape excavation profile of 100mm long x 20mm wide x 16mm deep and Y=1550mm having boat shape excavation profile of 110mm long x 30mm wide x 22mm deep. During welding, ABF QC Scott Kurtom was noted monitoring the welders' welding parameter with measured working current of 130 amperes on the 3.2mm diameter E7018H4R electrode. After the welding completion, the welder performed the Post Weld Heat Treatment (PWHT) of 450°F using propylene gas torch and held it for one hour as required. Welder James Zhen has completed from inside the repairs listed below;

1. 370mm 100mm 20mm 16mm 201209-084 R3 - Completed.
2. 1510mm 110mm 30mm 22mm 201209-083 R2 - Completed.

At OBG 13W-W2.3-@4440 drop-in top deck plate inside, QA randomly observed ABF/JV qualified welder Richard Garcia continuing to perform CJP groove welding repair from location Y=1300mm to Y=2800mm. The welder was observed manually welding in the 4G (overhead) position utilizing dual shielded Flux Cored Arc Welding (FCAW-G) with 1.6mm diameter electrode implementing Caltrans approved welding procedure ABF-WPS-D15-3110-4. The whole repair length has been excavated and being welded per Caltrans approved Request for Weld Repair (RWR) #201209-022 thru #201209-033. The repair excavation was preheated to more than 225 degree Fahrenheit using Miller Proheat 35 Induction Heating System with the heater blanket put in place on top of the deck prior/during excavation. The welder pumped up the preheat to more than 325°F during welding. ABF QC Cris Concha was noted monitoring the welder with measured working current of 240 amperes and 23.3 volts. During the shift, repair welding at location mentioned above was completed and the welder has moved to another location Y=0mm to Y=1300mm of the same field splice butt joint. The welder held the same preheat and held it for three (3) hours after welding as required. The welder was noted excavating using carbon air arc gouging the UT detected defects from Y=0mm to Y=1300mm. The whole repair length area being excavated was preheated using the same Miller Proheat 35 prior/during excavation.

Testing (UT) detected defect on welded butt joint. The welder was given approval to excavate two (2) repairs per Caltrans approved Request for Weld Repair (RWR) #201209-083 and #201209-084. The welder preheated the repair area and its vicinity to $>225^{\circ}\text{F}$ using propylene gas torch prior excavation and then ground smooth the groove of the excavation. After its completion, ABF QC performed Magnetic Particle Testing (MT) on the removal of the defects with no relevant defect noted during the test.
